# **CITY OF HAMILTON**

Efficient condition management of sewer  
systems using both Zoom Camera technology  
and "Traditional CCTV"

By Kevin Bainbridge and Harry Krinas, Department of Public Works, Asset Management Section, City of Hamilton

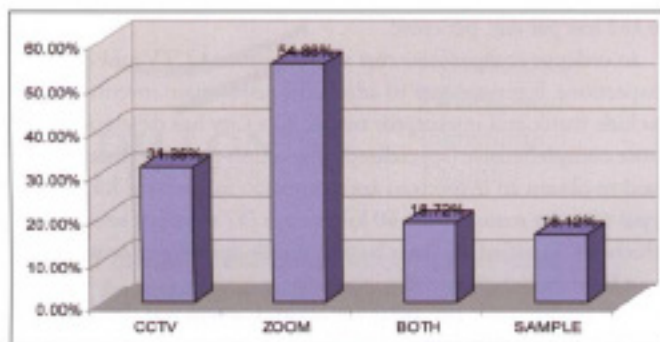
CCTV inspections to date have covered 31.35 per cent (823 kilometres / 511 miles) and Zoom Camera inspections have covered 54.86 per cent (1,441 kilometres / 895 miles) of the entire system. A sample set of sewers, which have been inspected by both Zoom Camera and CCTV within the last four years was extracted from all completed inspections. This resulted in a set of inspection data which covered 460 kilometres (286 miles) or 18.72 per cent of the system. This group was then screened for sewers which had been rehabilitated or replaced in the past four years in order to eliminate inspection data collected after the rehabilitation or replacement had occurred. This results in 423 kilometres (263 miles) of inspections representing 16.12 per cent of the entire system to be used for comparison purposes. In order to understand the accuracy of Zoom Camera inspections, some statistical comparisons were made in the difference between the condition ratings derived through Zoom Camera inspections versus CCTV inspections, two distinct areas of comparison were made.

- a) Error Deviation
- b) Error Deviation by Segment Length

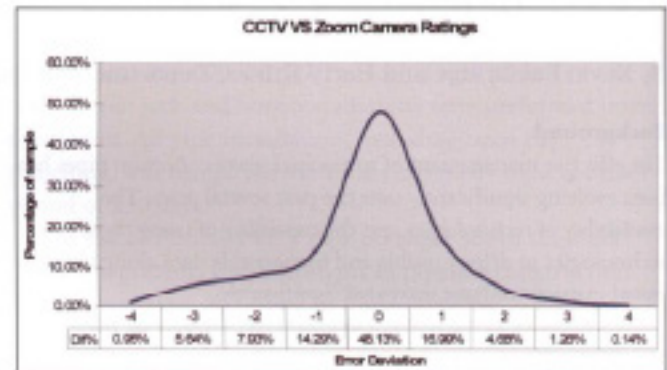
### Ratings CCTV-Zoom Error Deviation

The entire sample was analyzed to produce the spread of difference in ratings between CCTV and Zoom results. Chart 2, "Spread of Rating Differences" demonstrates in percentage of sample pipe length the deviation of Zoom Camera ratings from CCTV ratings. The X-axis represents the error in Zoom rating and the Y-axis represents the percentage of sample pipe found to be inside the error deviation zone. For example, 1) Zoom Camera is equal to CCTV ratings 48.13 per cent of the time. 2) Zoom Camera shows a better condition rating by one 14.29 per cent of the time. 3) Zoom Camera shows a worst condition rating by one condition rating compared to CCTV 16.99 per cent of the time.

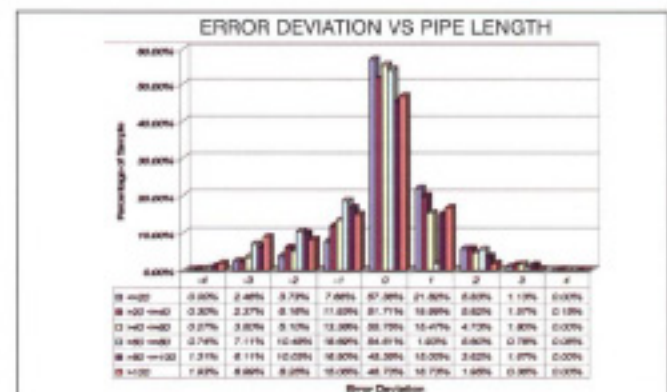
### Zoom Camera Rating Reliability by Segment Length

Since Zoom Camera on average can only inspect the first and last 30 metres (98 feet) of pipe segments under optimal conditions, it is necessary to investigate how pipe length influences Zoom Camera rating accuracy.

The following chart (Chart 3) demonstrates the effect of pipe length in Zoom Camera rating error (x-axis +/- error). Six groups of pipe lengths in 20-metre (66-foot) intervals are used in this example. The first thing noticed here is that @ error deviation 0 (no difference in CCTV and Zoom Camera ratings) the value drops from 57.36 to 46.73 indicating that the accuracy is effected by length. Reading the chart table horizontally, one is able to observe what the pipe length impact is on Zoom Camera ratings across each error deviation.

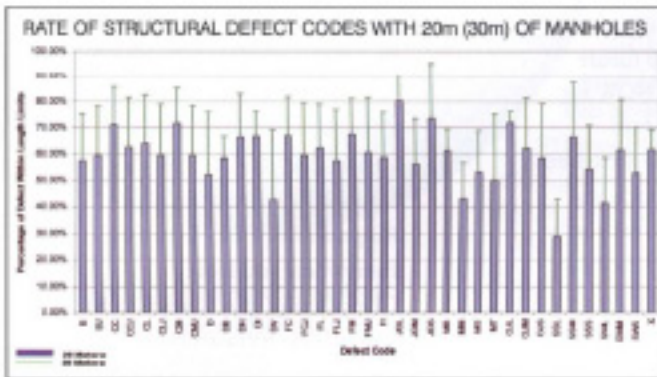
### Pipe Defect Location

In order to better understand the accuracy of the Zoom Camera condition ratings, the capability of Zoom Cameras needs to be understood. Given that zoom cameras are limited in their capability of inspecting the entire length of typical sewers (80 metres / 26 feet) due to the potential presence of

obstructions in a sewer pipe, e.g., bends, major blockage, protruding services, etc., Zoom Cameras are typically capable of viewing defects which occur in the first 20 to 30 metres (66 to 98 feet) of pipe. Therefore, if we use CCTV data to understand statistically where the majority of defects are identified as a function of distance from the manhole structures, we can obtain a better understanding of the accuracy of Zoom Camera inspection. Essentially, we are trying to understand statistically how many defects Zoom Camera inspections are missing.

On average, 59.44 per cent of defects are found within 20 metres (66 feet) of manholes and 76.12 per cent are found within 30 metres (98 feet) of manholes.

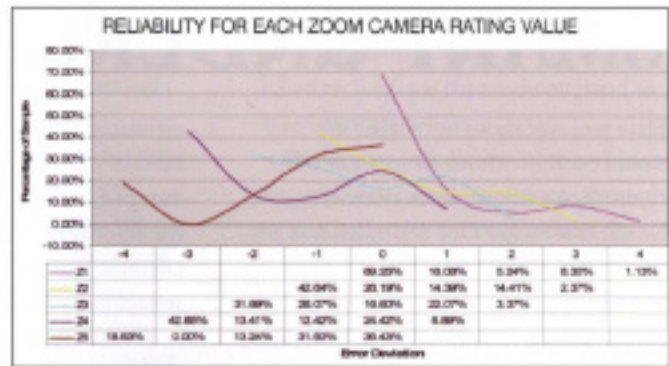
### Zoom Camera Rating Reliability

Finally, the reliability of Zoom Camera ratings was individually compared to CCTV ratings to produce a reliability level presented as a percentage of pipe length in each group. Z1 to Z5 represent each Zoom Camera rating and the X-axis is the rating error deviation as compared to CCTV ratings. For example, when Zoom Camera indicates a rating of 1, the actual rating is 1 with 69.25 per cent certainty, the actual rating is 2 with 16.08 per cent certainty, the actual rating is 3 with 5.24 per cent certainty and so on ...
